DEPARTMENT OF THE ARMY  
UNITED STATES ARMY AVIATION TEST BOARD  
Fort Rucker, Alabama 36360

SUBJECT: Letter Report, (6) Product-Improvement Test of Component  
TBO Extension, UH-1( ) Helicopter, RDT&E Project No.  
(16) USATECOM Project No 4-5-0101-03

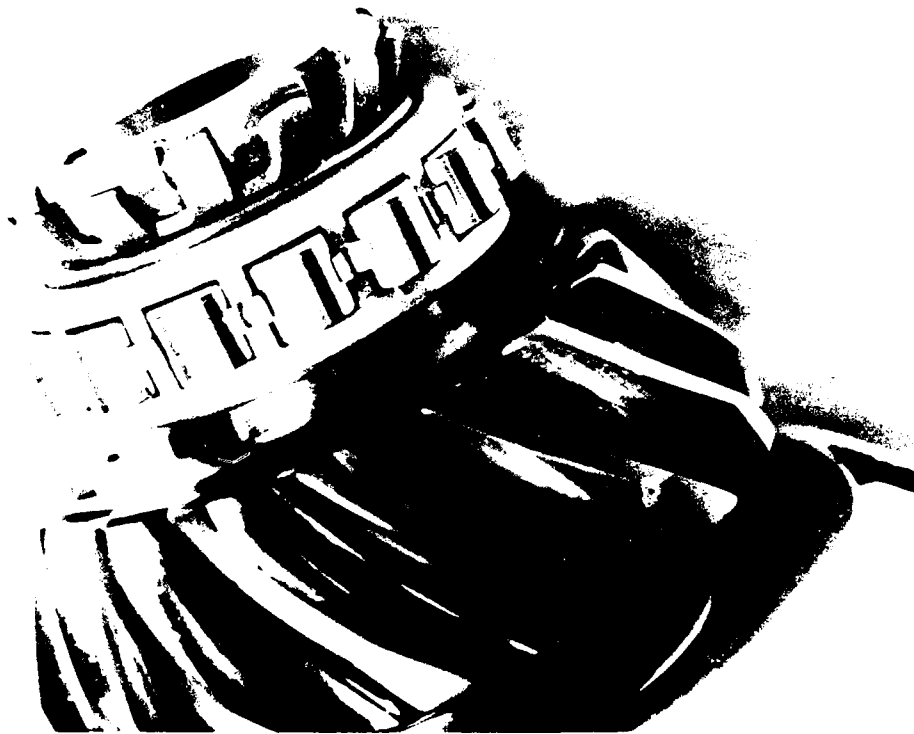
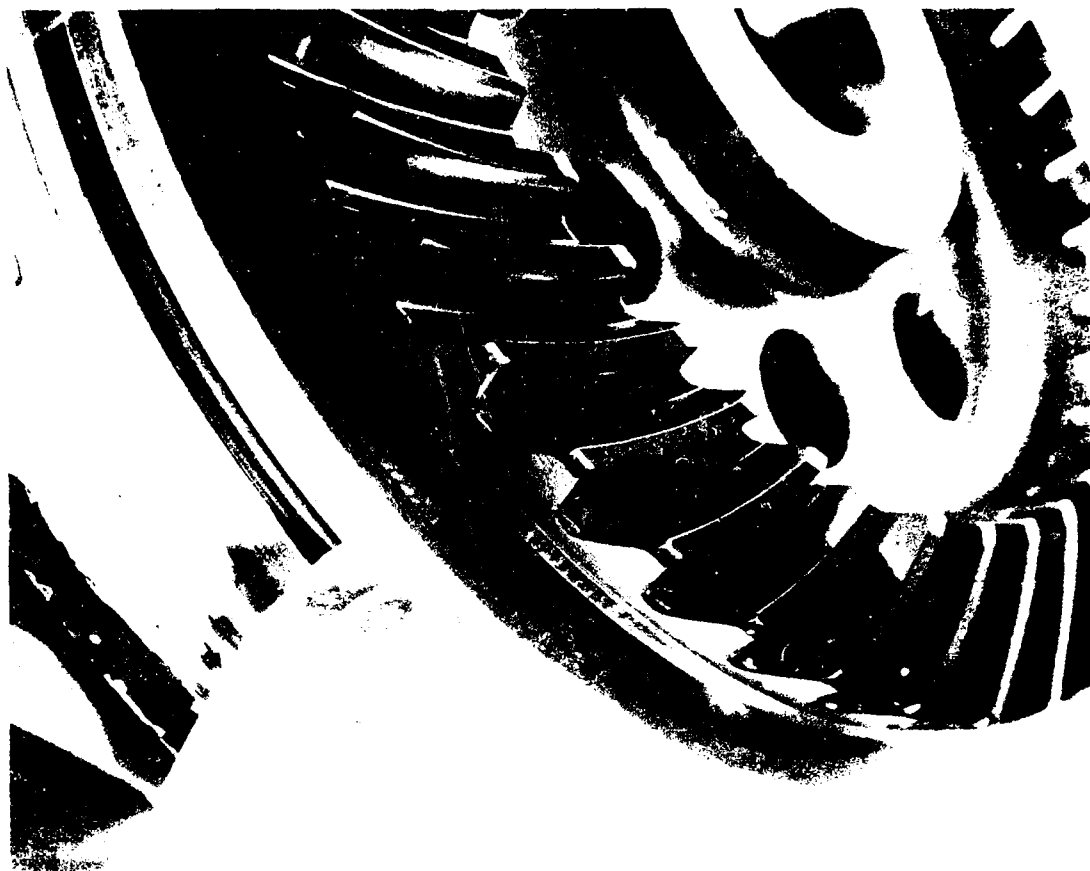
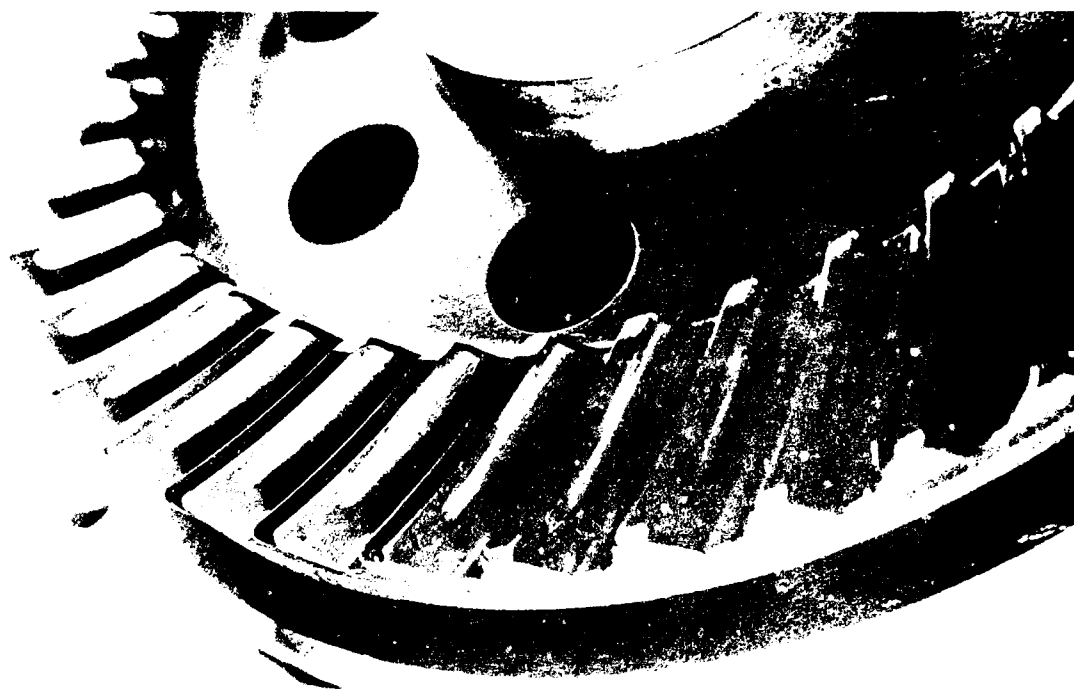
b. S/N B13-1285. This gearbox had operated 1096.0 hours in RVN. The gearbox was inspected and photographed (figures 52, 53, 54, and 55). The wear and backlash patterns that were observed at the 1096-hour inspection are shown in figure 56. The input quill bearings had some light roughness in rotation; however, the output quill bearings rotated smoothly. The gearbox was considered serviceable for testing. After accumulating 1168.7 hours, the gearbox was again inspected. Some change had occurred in the wear and backlash patterns on both gears (figure 57). The tops of the input gear teeth had developed some scratch-like marks, but these marks were not feel detectable. The input quill bearings still had light roughness in rotation; however, the output quill bearings rotated smoothly. The gearbox was considered serviceable for further testing and was reinstalled. After accumulating 1300.8 hours, the gearbox was again inspected. The wear pattern on the concave side of the input gear had not changed. A slight change, however, had occurred in the backlash pattern on the convex side of the input gear (figure 58). The wear or backlash pattern on the output gear had not changed since the 1168.7-hour inspection; however, a discrepancy had developed on the convex (load) side of the output gear. The discrepancy appeared to be a hairline crack in the center of the gear (figures 58 and 59); microscopic examination revealed it to be a series of small interlocking pits. The pits appeared on approximately 90 percent of the output gear teeth. The lines of pitting varied from 0.125 to 0.187 inch in length. This gearbox, which was considered unserviceable after accumulating 1300.8 hours, and a gearbox, S/N B13-1276, which is discussed in paragraph g, and which had a similar discrepancy, were taken to USAADMAC for laboratory analyses. Laboratory analyses (USAADMAC

Figure 52. Convex side of input gear teeth.  
(90-degree gearbox, S/N B13-1285, 1096.0  
operating hours.)

Figure 10. Close-up view of a pair gear teeth.  
(90-degree gear loss, 8.7% loss, 100%  
operating hours.)

Figure 54. Concave side of output gear teeth.  
(90-degree Le root, S. N. B13-1285, 1096.0  
operating hours.)

Figure 55. Convex side of output gear box  
(90-degree gearbox, S/N B15-1284, 1000  
operating hours.)

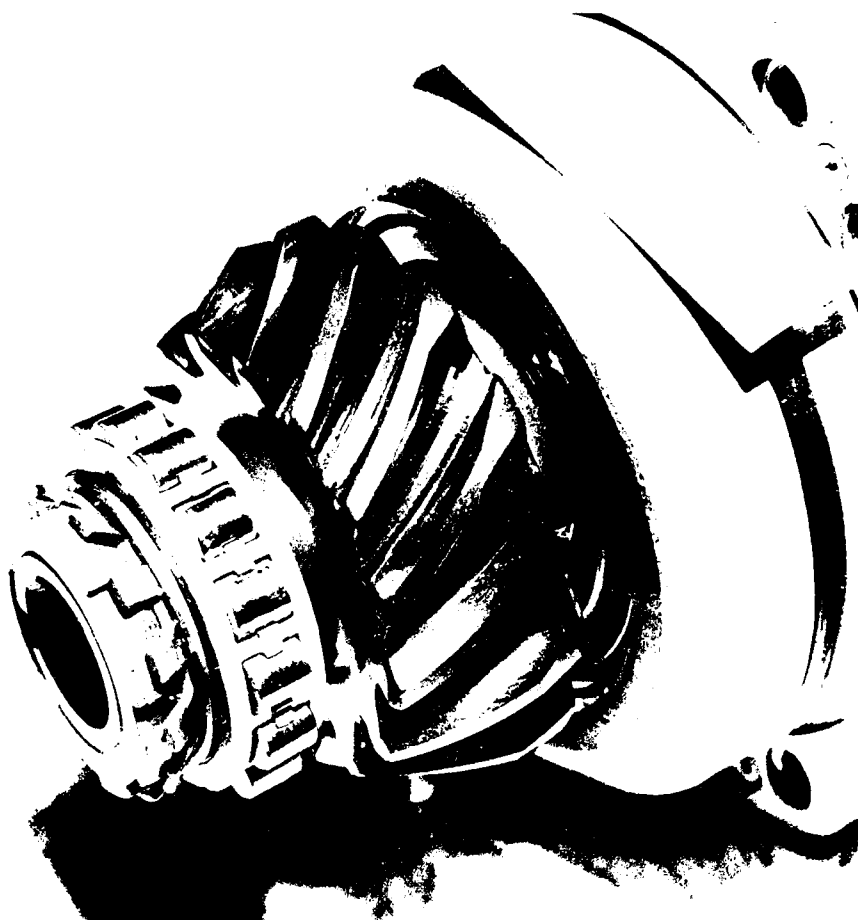
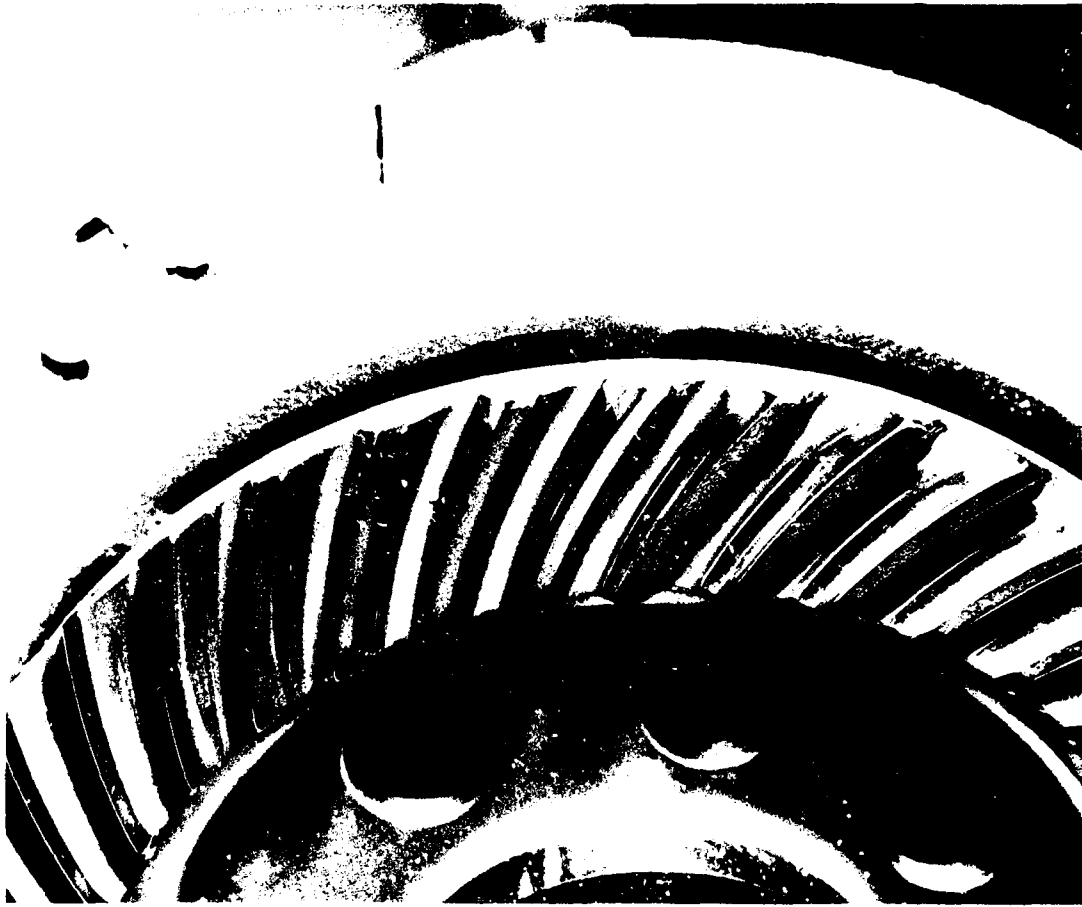
c. S/N B13-1499. This gearbox had operated 1095.0 hours in RVN. The gearbox was disassembled and photographed (figures 61 and 62). Inspection revealed no discrepancies. The input quill bearings exhibited a very light roughness. The output quill bearings rotated smoothly. The wear and backlash patterns that existed at 1095.0 hours are shown in figure 63. The gearbox was considered serviceable for test and accumulated 1197.4 hours prior to the next inspection. The wear and backlash pattern had changed on both gears (figure 64). The input quill still had a slight roughness; however, the output quill rotated smoothly, and the gearbox was considered serviceable for additional testing. After accumulating 1301.3 hours, the gearbox was again inspected. The wear and backlash patterns had not changed since the 1197.4-hour inspection; however, pitting had developed on the convex (load) side of the output gear along the line where the two wear patterns overlap. The pitting was similar in all respects to that observed on gearbox, S/N B13-1285. Minor pitting was also evident on the load side of both the input and output gears. The gearbox was considered unserviceable after accumulating 1301.3 hours.

Figure 61. Convex and concave sides of input gear teeth (90-degree gearbox, S/N B13-1499, 1095.0 operating hours).

Figure 62. Convex and concave sides of output gear teeth (90-degree gearbox, S/N B13-1499, 1095.0 operating hours).

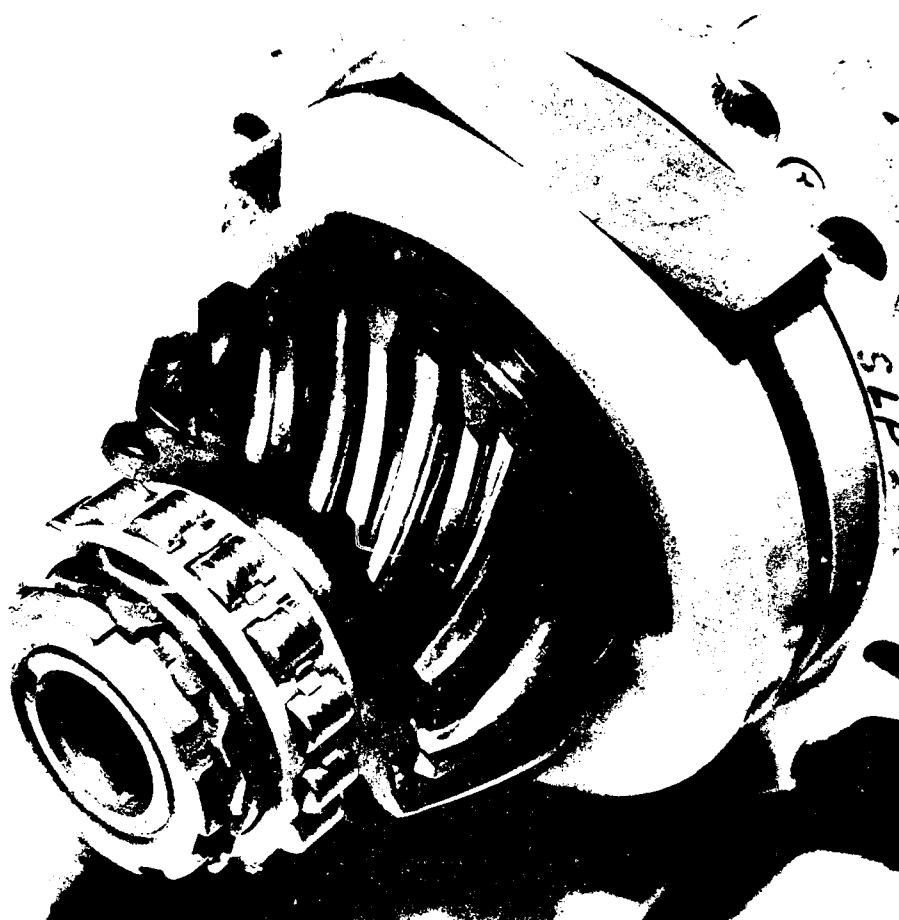
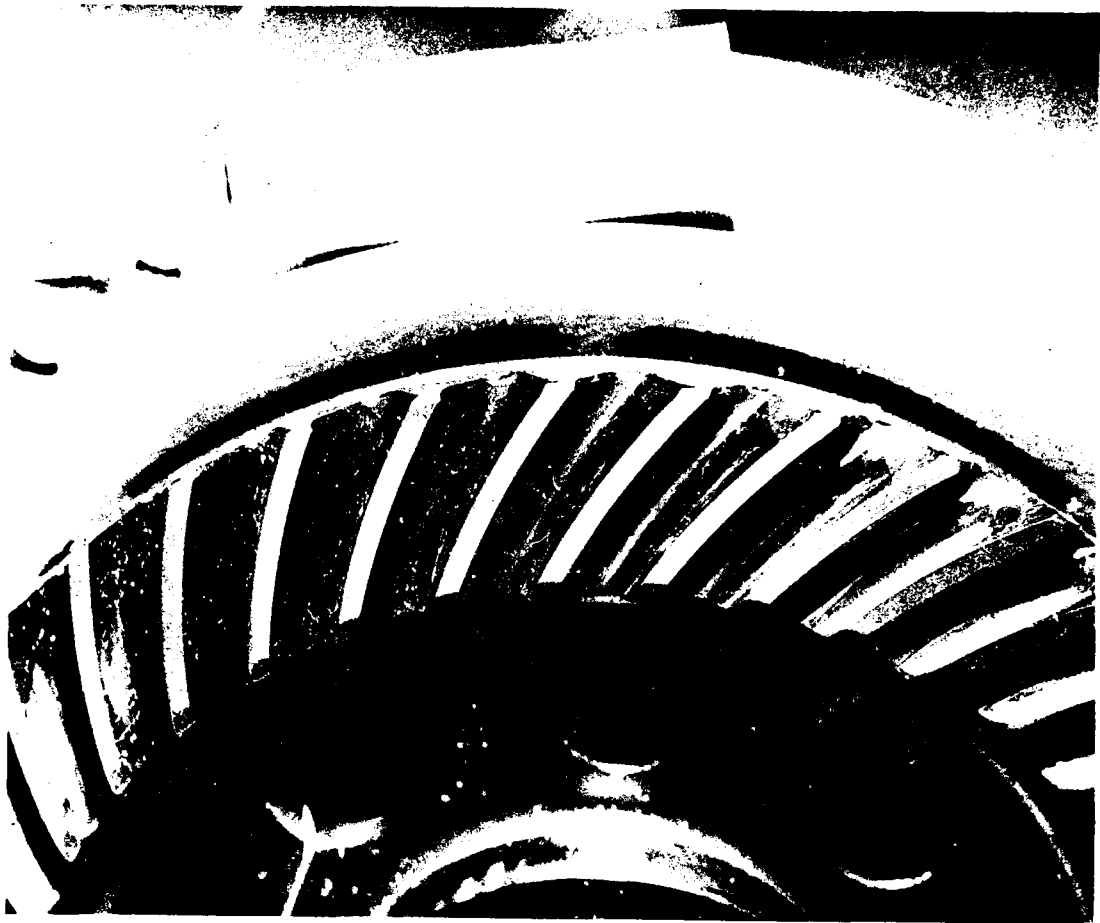
d. S/N B13-1233. This gearbox had operated 1088.0 hours in RVN. The gearbox was inspected and photographed prior to testing (figures 65 and 66). Inspection revealed a small scratch-like mark on the top of the outboard convex end of one of the input gear teeth. The wear and backlash patterns that were present are shown in figure 67. The bearings in both quills rotated smoothly. The gearbox was serviceable for testing and accumulated 1183.0 hours prior to the next inspection. The wear and backlash patterns on the output gear teeth had changed since the last inspection (figure 68). The wear and backlash patterns had not changed on the input gear. Both quills' bearings rotated smoothly. The gearbox was serviceable for additional testing and accumulated 1310.3 hours prior to the next inspection. The wear and backlash patterns on the load side of both gears were basically unchanged. The only exception was that the backlash pattern on the input gear seemed to have extended itself longitudinally over a larger area of the tooth. Concentrated interlocking pitting, however, was noted at the pattern-overlap area on the convex side of the output gear. The interlocking pits appeared on 12 of the teeth and varied in length from 0.062 to 0.125 inch (figure 69). The pitting was the same as that observed on gearbox, S/N B13-1285. In addition to numerous very small pits on the load side of both gears, an area of pick-out appeared on four of the input gear teeth on the concave (load) side where an overlap of patterns appeared. One pit measured 0.125 inch in length and 0.031 inch in width (figure 70). The bearings on both quills rotated smoothly; however, the gearbox was considered unserviceable after accumulating 1310.3 hours.

Figure 65. Convex and concave sides of input gear teeth (90-degree gearbox, S/N B43-1233, 1088.0 operating hours).

Figure 66. Convex and concave sides of output gear teeth (90-degree gearbox, SN B13-1233, 1088.0 operating hours).

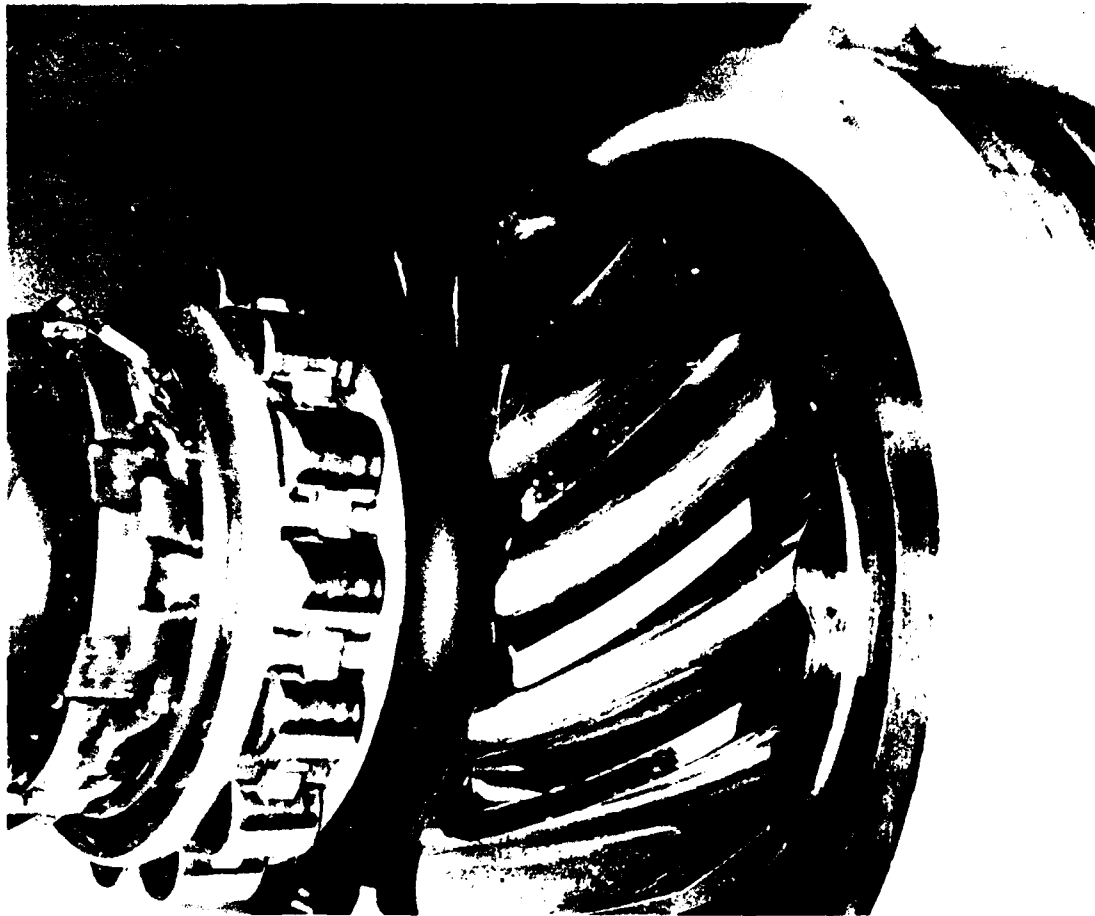
e. S/N B13-1068. This gearbox had operated 1091.0 hours in RVN. The gearbox was disassembled and photographed (figures 71, 72, 73, and 74). No discrepancies were noted, and the bearings in both quills rotated smoothly. The wear and backlash patterns are shown in figure 75. The gearbox was considered serviceable and accumulated 1191.4 hours prior to the next inspection. No change in the wear or backlash patterns was evident on either gear, and the bearings in both quills rotated smoothly. No discrepancies of any kind were present on the gear teeth, and the gearbox was determined serviceable for further testing. During the next 50.5 hours, spectrographic oil analysis revealed the following:

Figure 71. Convex side of input gear teeth  
(90-degree gearbox, S/N B13-1068, 1091.0  
operating hours).

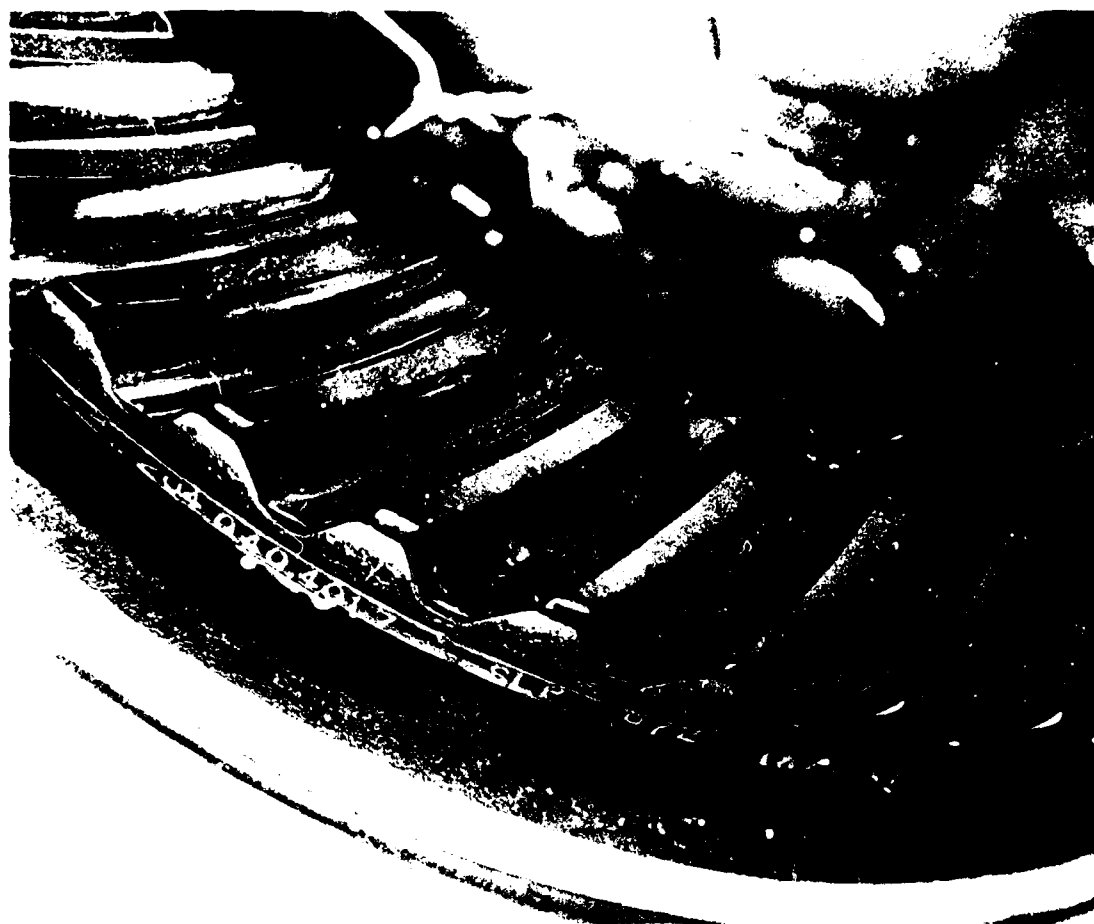
Figure 72. Concave side of input gear teeth  
(90-degree gearbox, S/N B13-1068, 1091.0  
operating hours).

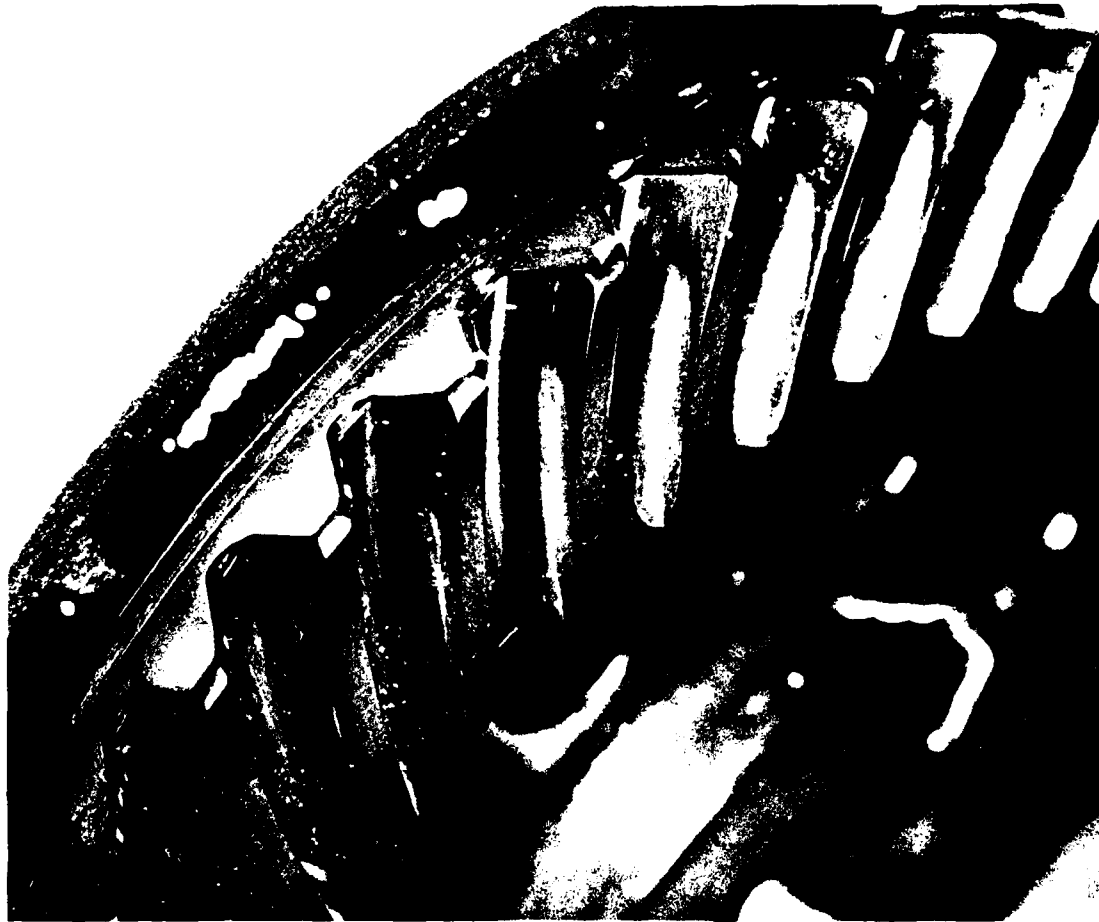
Figure 73. Concave side of output gear teeth  
(90-degree gearbox, S/N B13-1068, 1091.0  
operating hours).

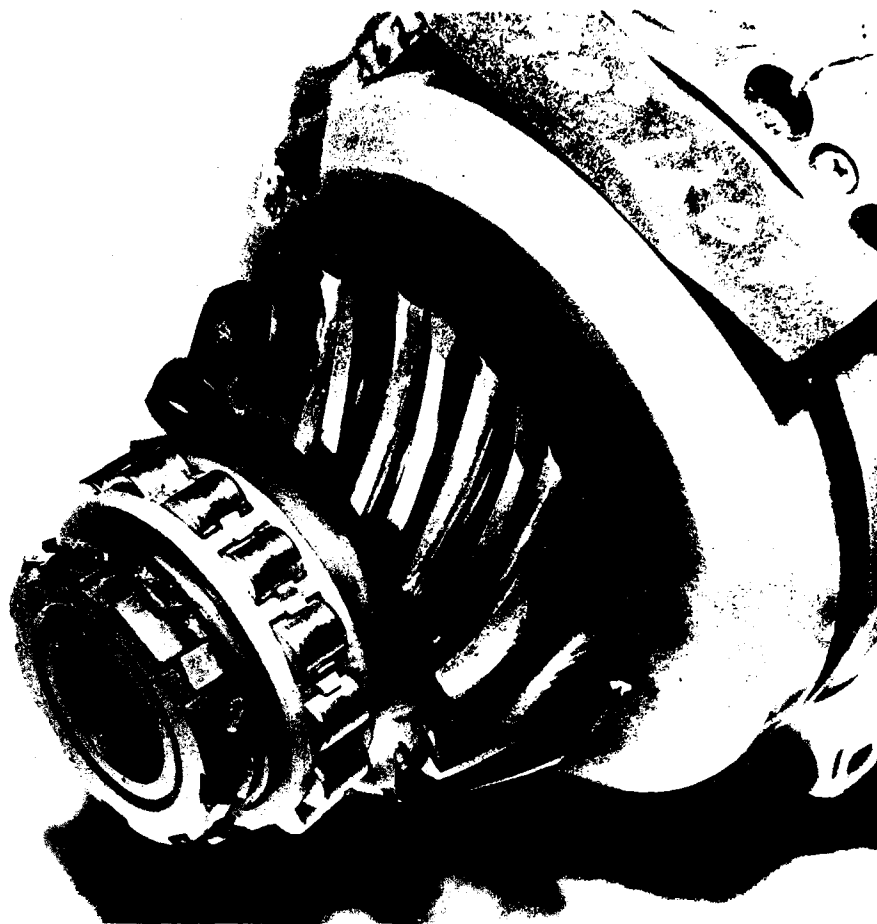
Rapid deterioration began sometime after 1224.0 component hours, and in less than 10 hours, iron contamination increased from a normal figure of 66 parts per million to 540 parts per million. The gearbox was disassembled at 1241.9 hours. Figures 76 and 77 show the deterioration on the load side of both the input and output gears. The unloaded sides of both gears showed no change in backlash pattern. The bearings in both quills rotated with some roughness, which was probably caused by metal particles from the gears. This gearbox was unserviceable after 1241.9 hours.

Figure 77. Convex side of output gear teeth  
(90-degree gearbox, S/N B13-1068, 1241.9  
operating hours).

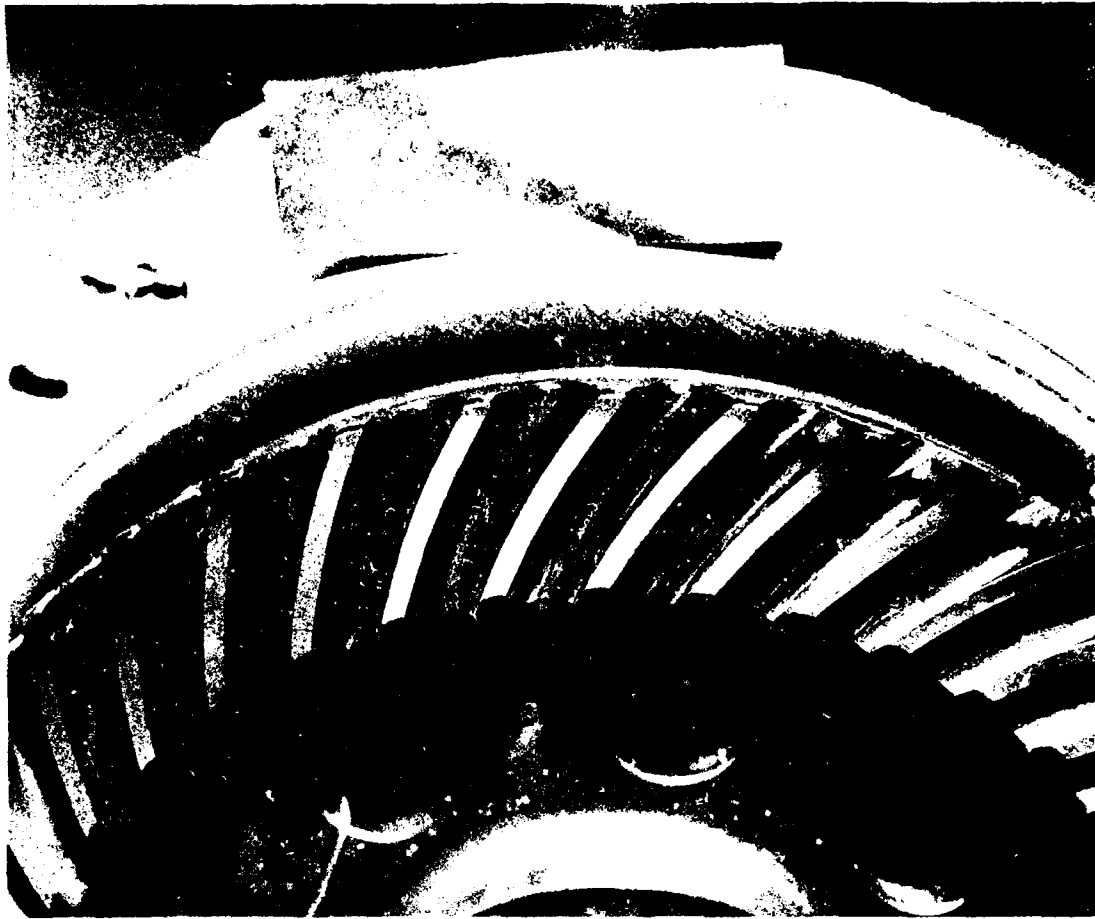
f. S/N B13-1209. This gearbox had operated 1080.0 hours in RVN. The gearbox was disassembled for inspection and photographed (figures 78 and 79). The wear and backlash patterns that were present are shown in figure 80. The bearings rotated smoothly, and the gearbox was considered serviceable for testing. After accumulating 1201.4 hours, the gearbox was again inspected. The wear and backlash patterns had not changed since the last inspection. The bearings on both quills turned freely, and no discrepancies were evident on the gears. The gearbox was considered serviceable for further testing. The gearbox accumulated 1245.9 hours by the next inspection. Disassembly revealed no change in the wear or backlash patterns; however, the same type of concentrated pitting had developed on the load or convex side of the output gear as had developed on gearbox, S/N B13-1285. The pitting was at the point of overlap of the two wear patterns (figure 81). A similar line of pits was present on the load (concave) side of the input gear where two

Figure 78. Convex and concave sides of input gear teeth (90-degree gearbox, S/N B13-1209, 1107.0 operating hours).

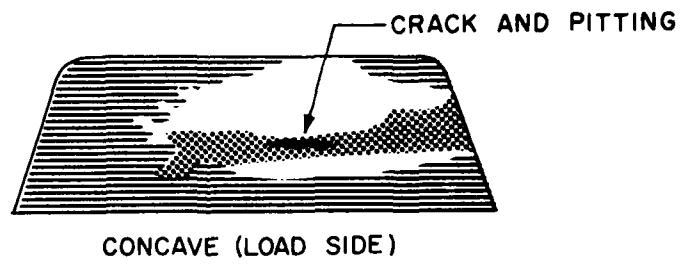
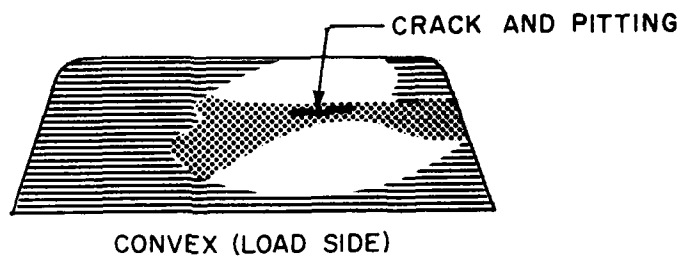
Figure 80.

90° GEAR BOX, S/N B13-1209, 1245.9 HOURS
